**MIDDLE NORTH SERIES  
DIAL PACK EVENT**

**PROJECT OFFICERS REPORT**

**PROJECT LN-318**

**TEST OF PRECAST CONCRETE  
UNDERGROUND STRUCTURE (U)**

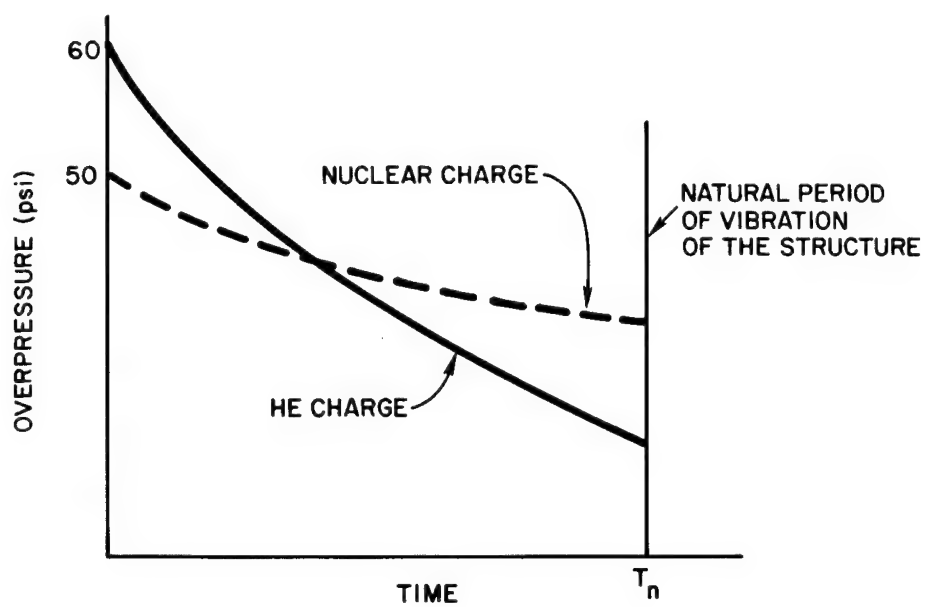
Figure 1. --Load impulse from impingement to natural vibration period.

A consideration of the impulse differences between the DIAL PACK Event and a megaton nuclear blast indicated the placement of the structure at a range corresponding to 60-psi overpressure in DIAL PACK Event (see figure 1). The test was designed to determine the extent of cracking, blast-induced deflections and relative motions, equipment environments, and overall structural response.

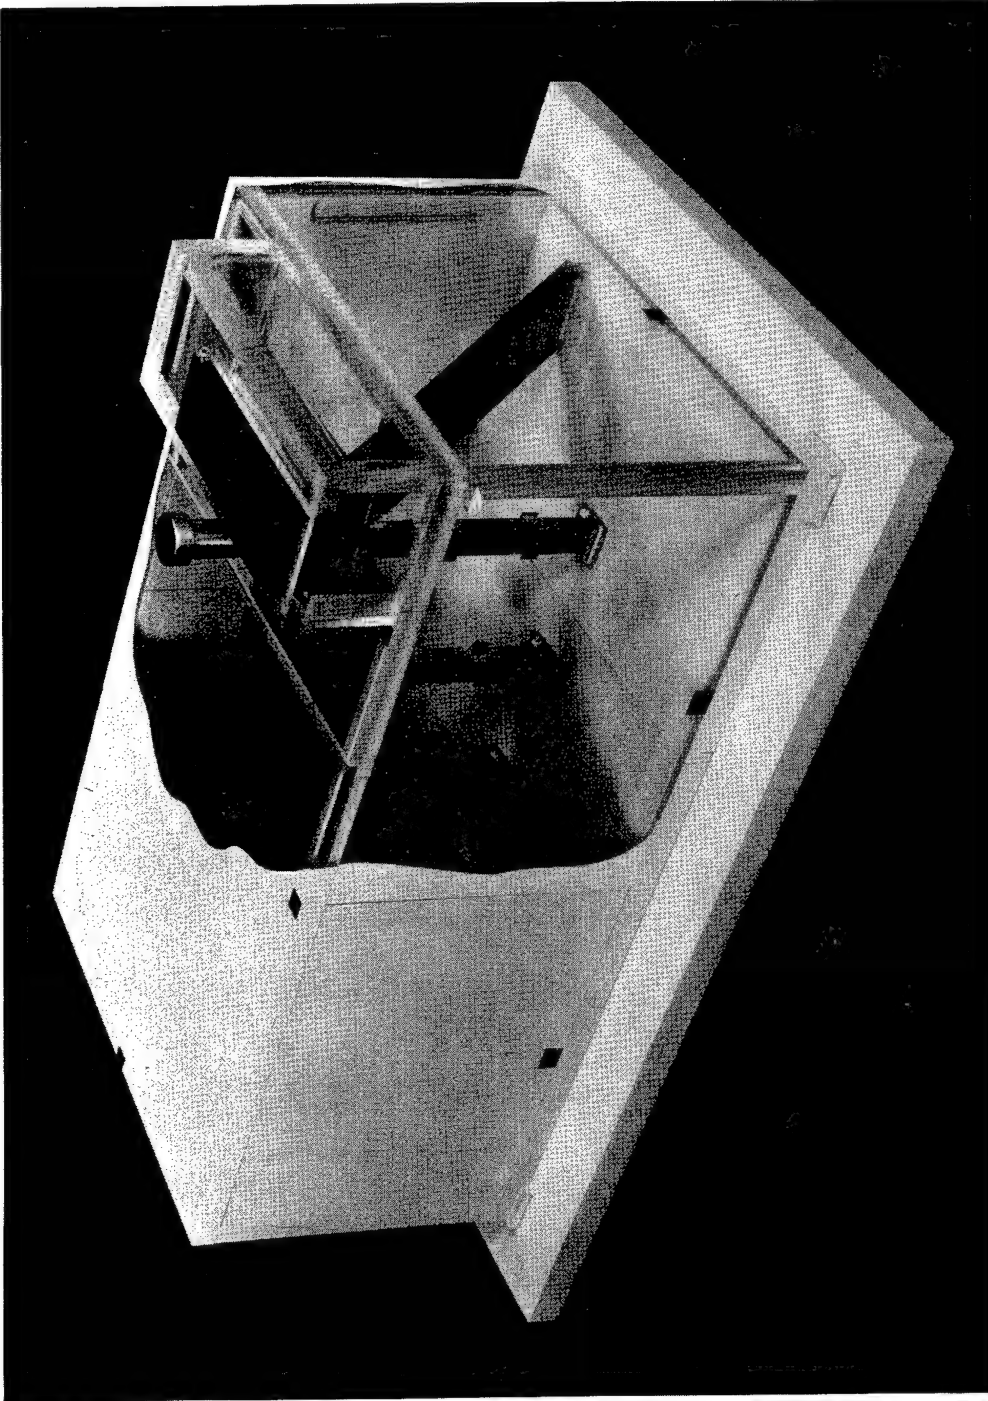
Figure 2. ---Model of the SA Manhole.

Figure 2 shows a model of the SA Manhole. The basic structure was made up of 12 precast concrete slabs, each 8-1/2 inches thick and roughly 9- by 13-feet in area. The interior dimensions of the structure were 12- by 24- by 8-feet. A structural steel frame supported the roof at mid-span, and a concrete collar section with a blast-hatch was mounted in the entry area and permitted a cover of 2 feet of earth over the roof of the structure. The blast-hatch, 2- by 6-feet in area, was made of cast aluminum in two parts; the sections folded to completely open the hatch area.

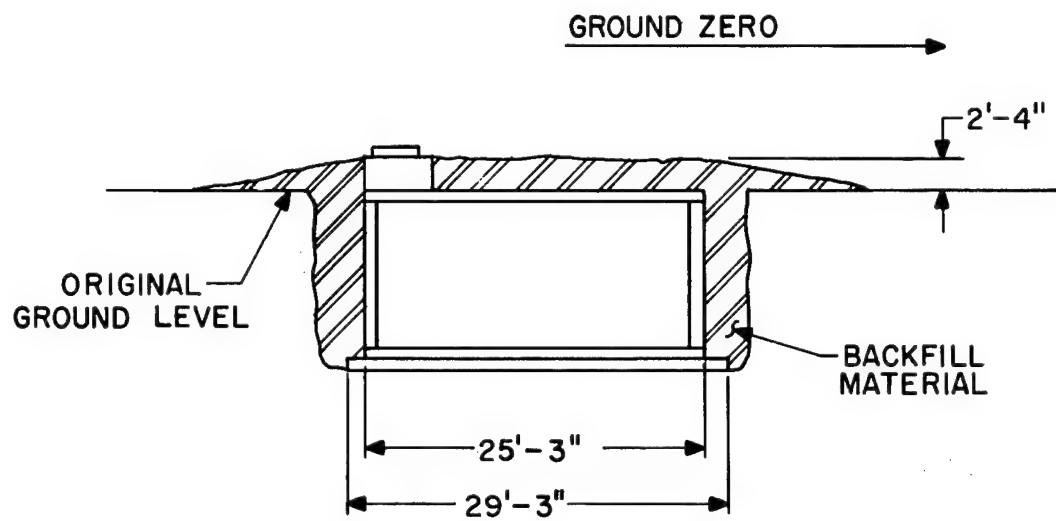
Figure 3. --Elevation view of the SA Manhole.

An elevation view of the installed manhole is shown in figure 3. An earth cover of approximately 2 feet was provided over the roof, sloping back to the original grade with about a 4 on 1 slope.

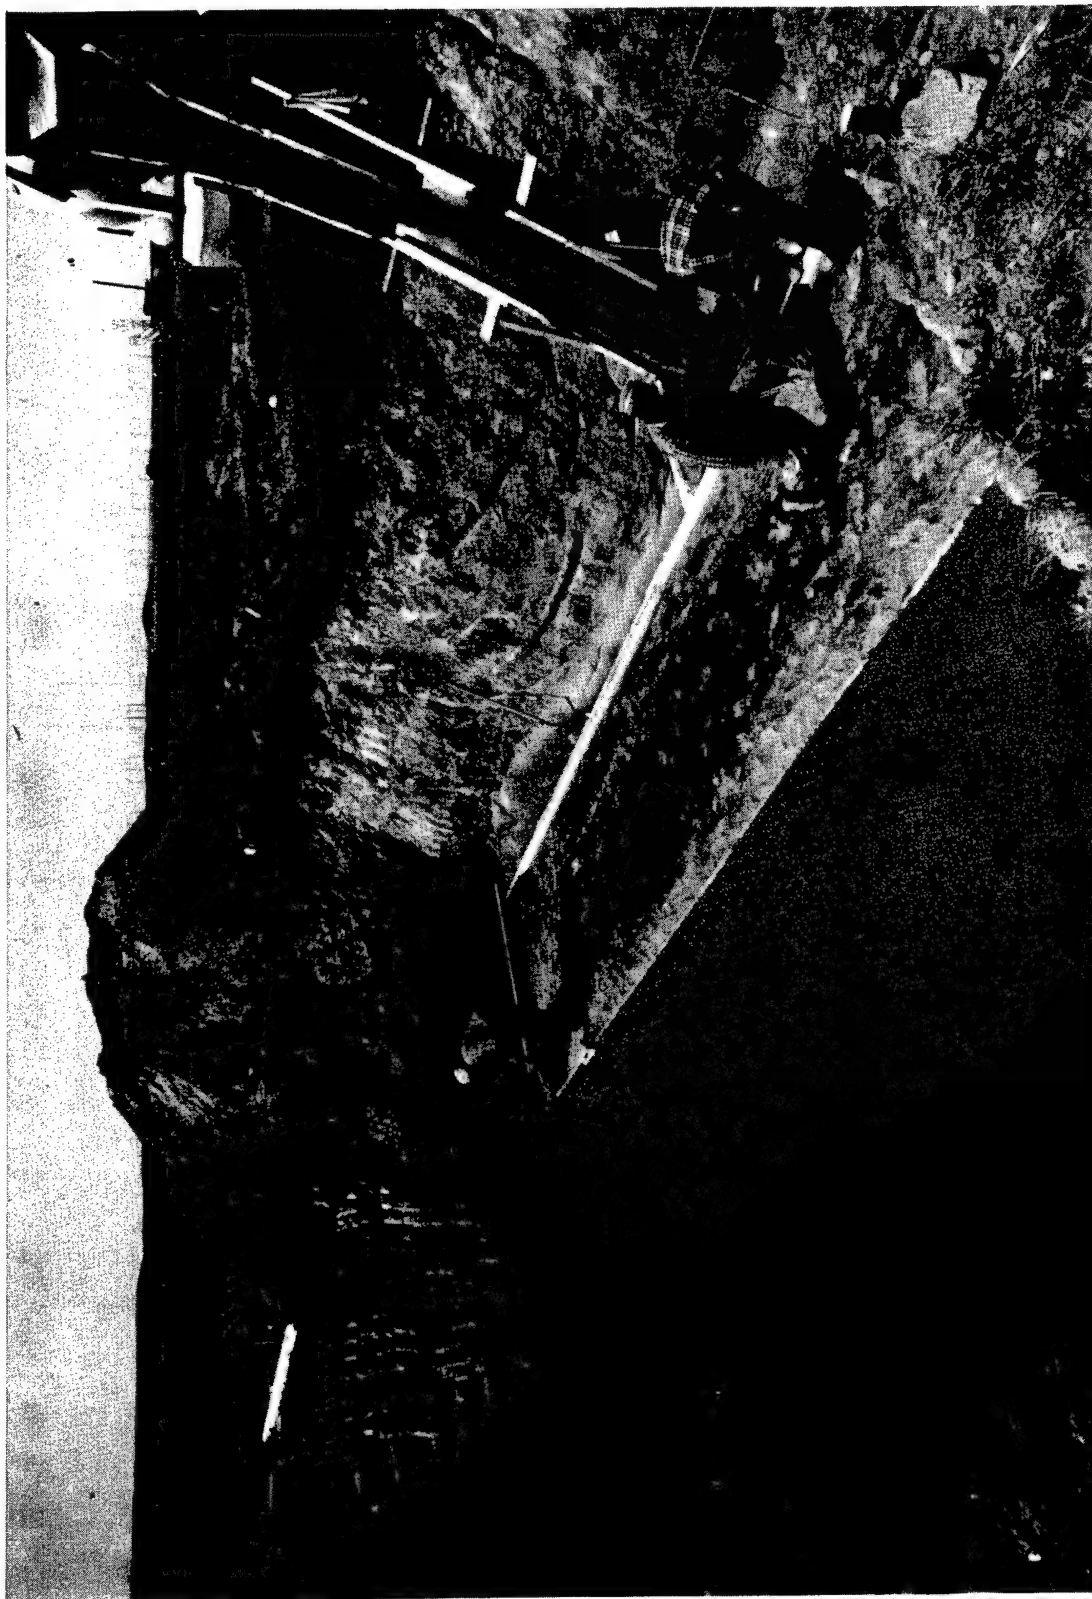
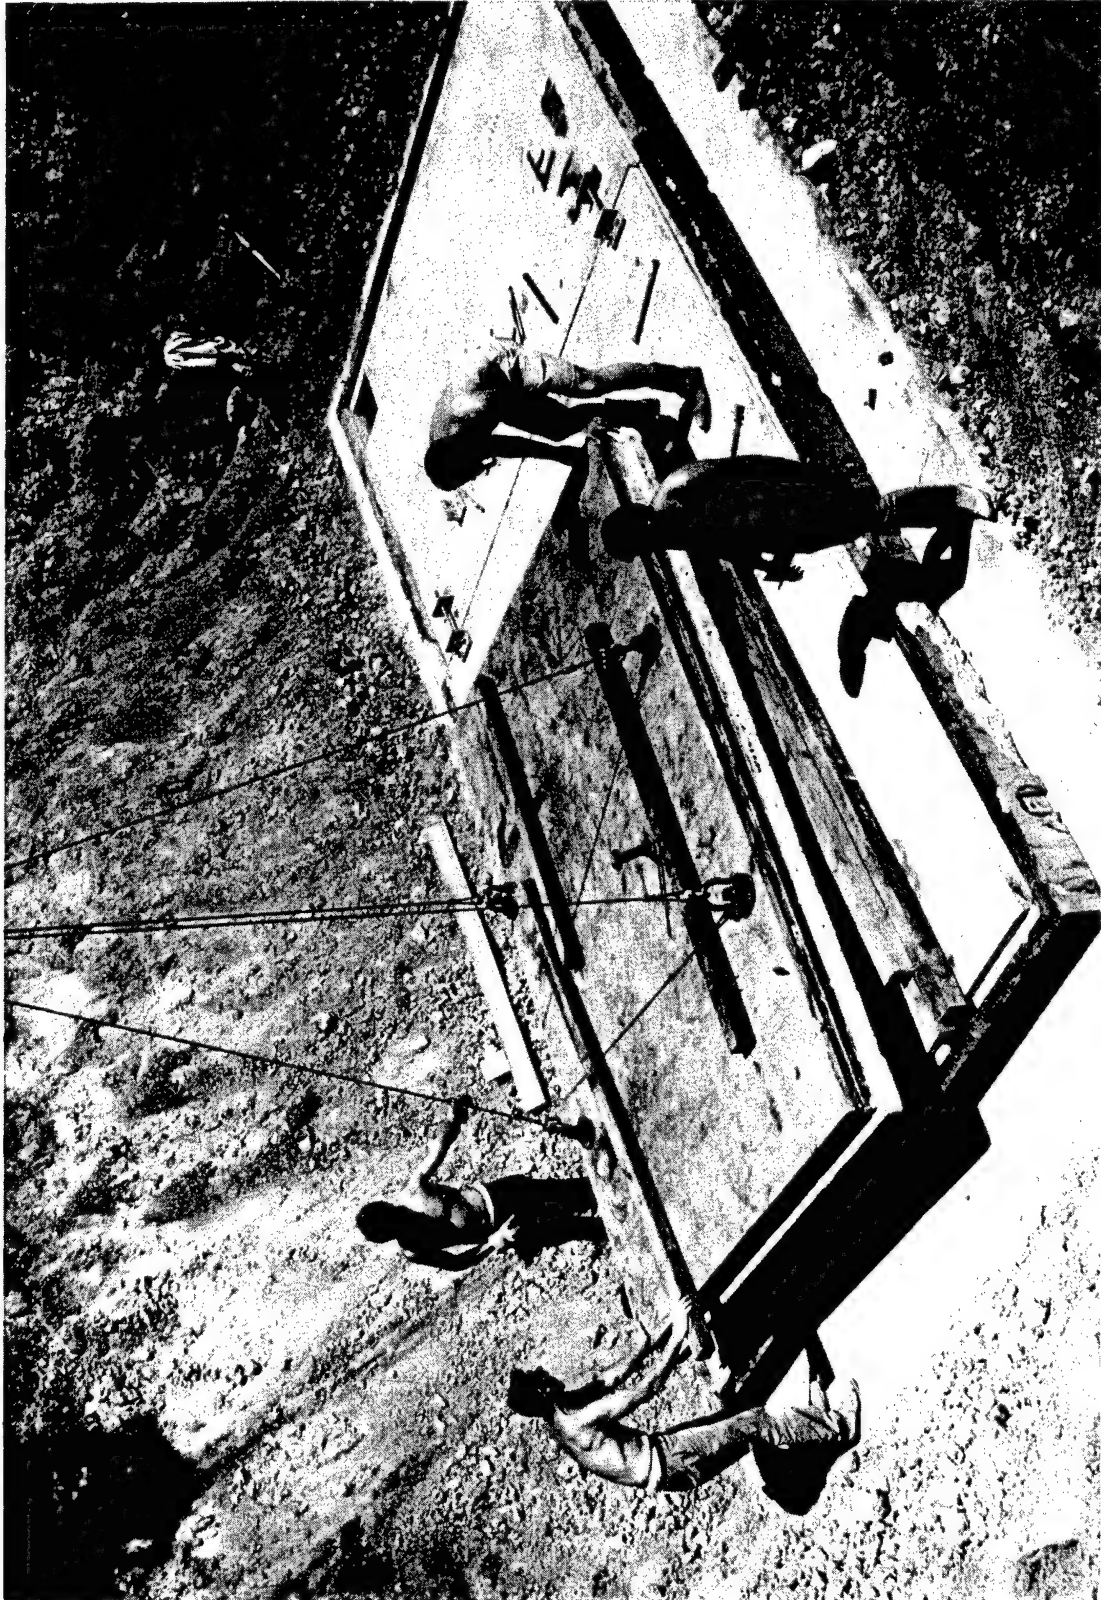
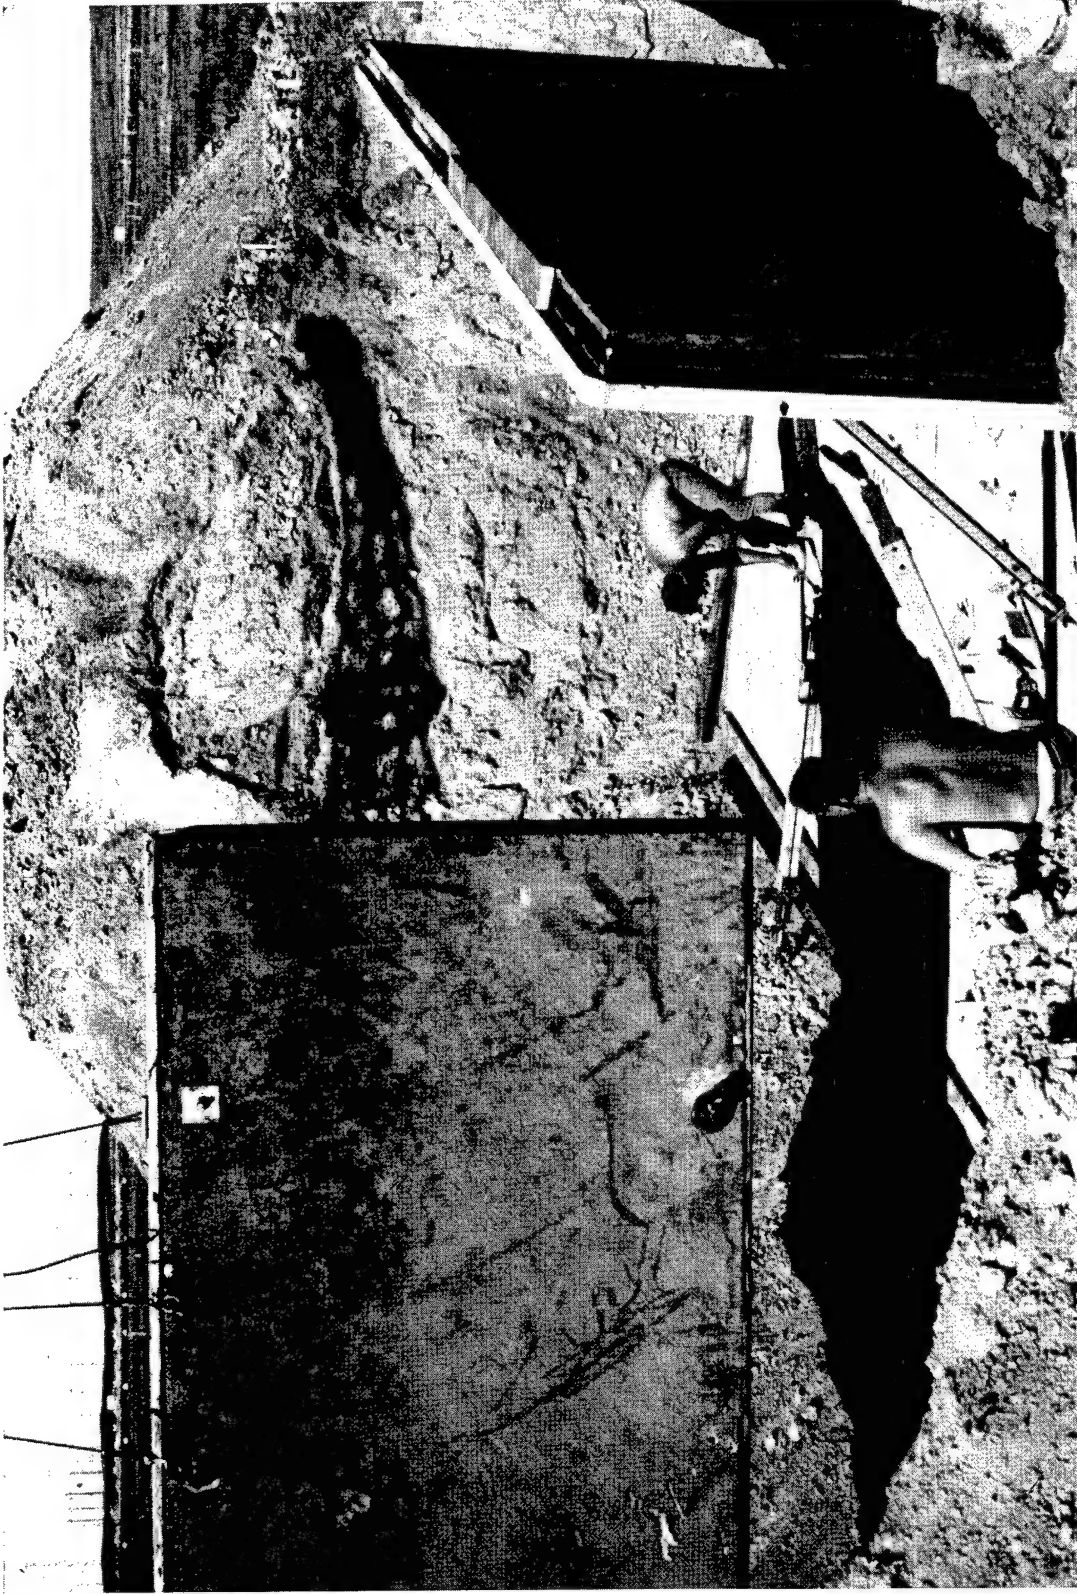
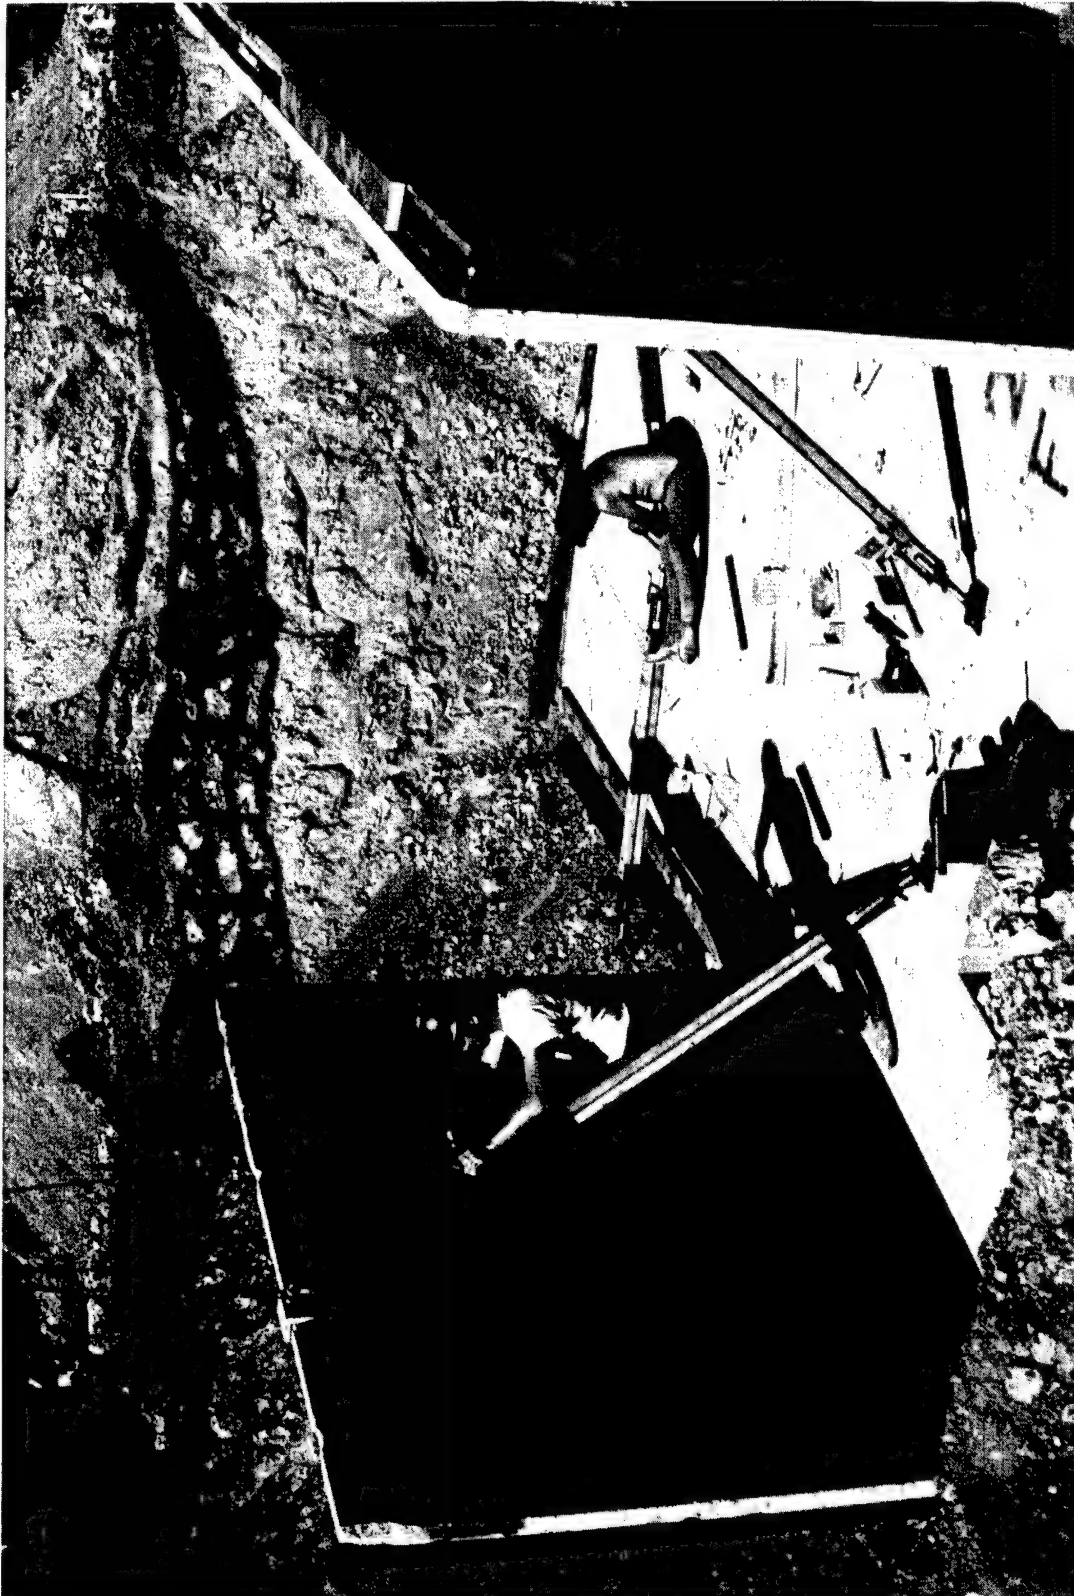
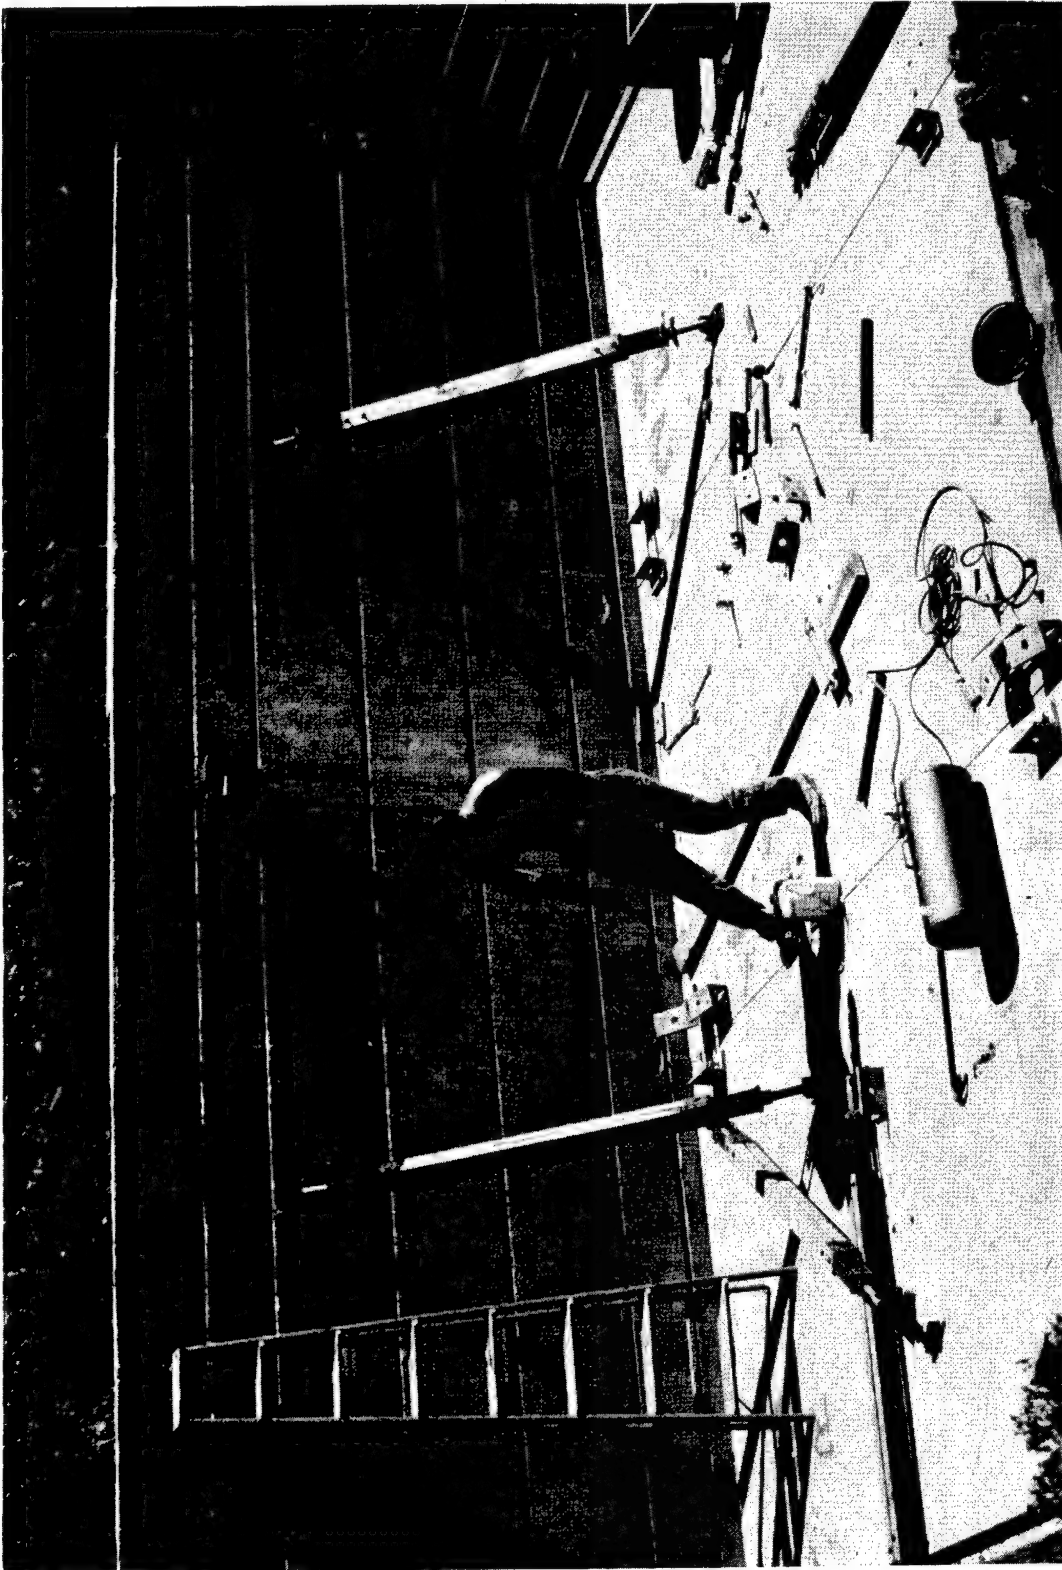
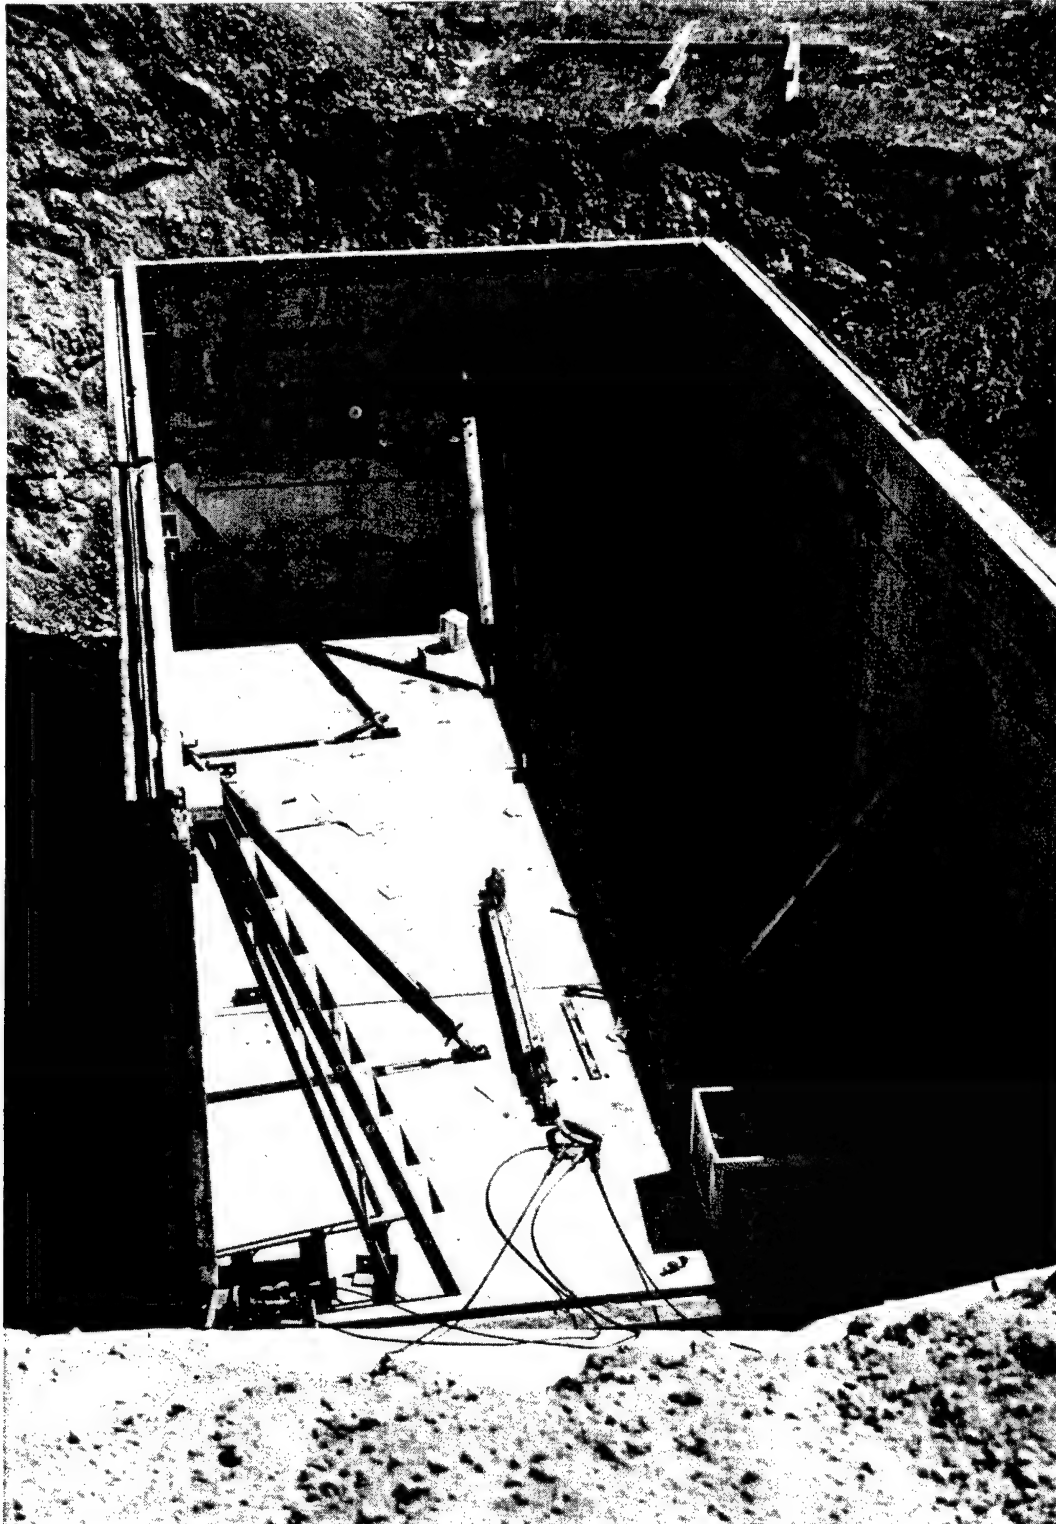
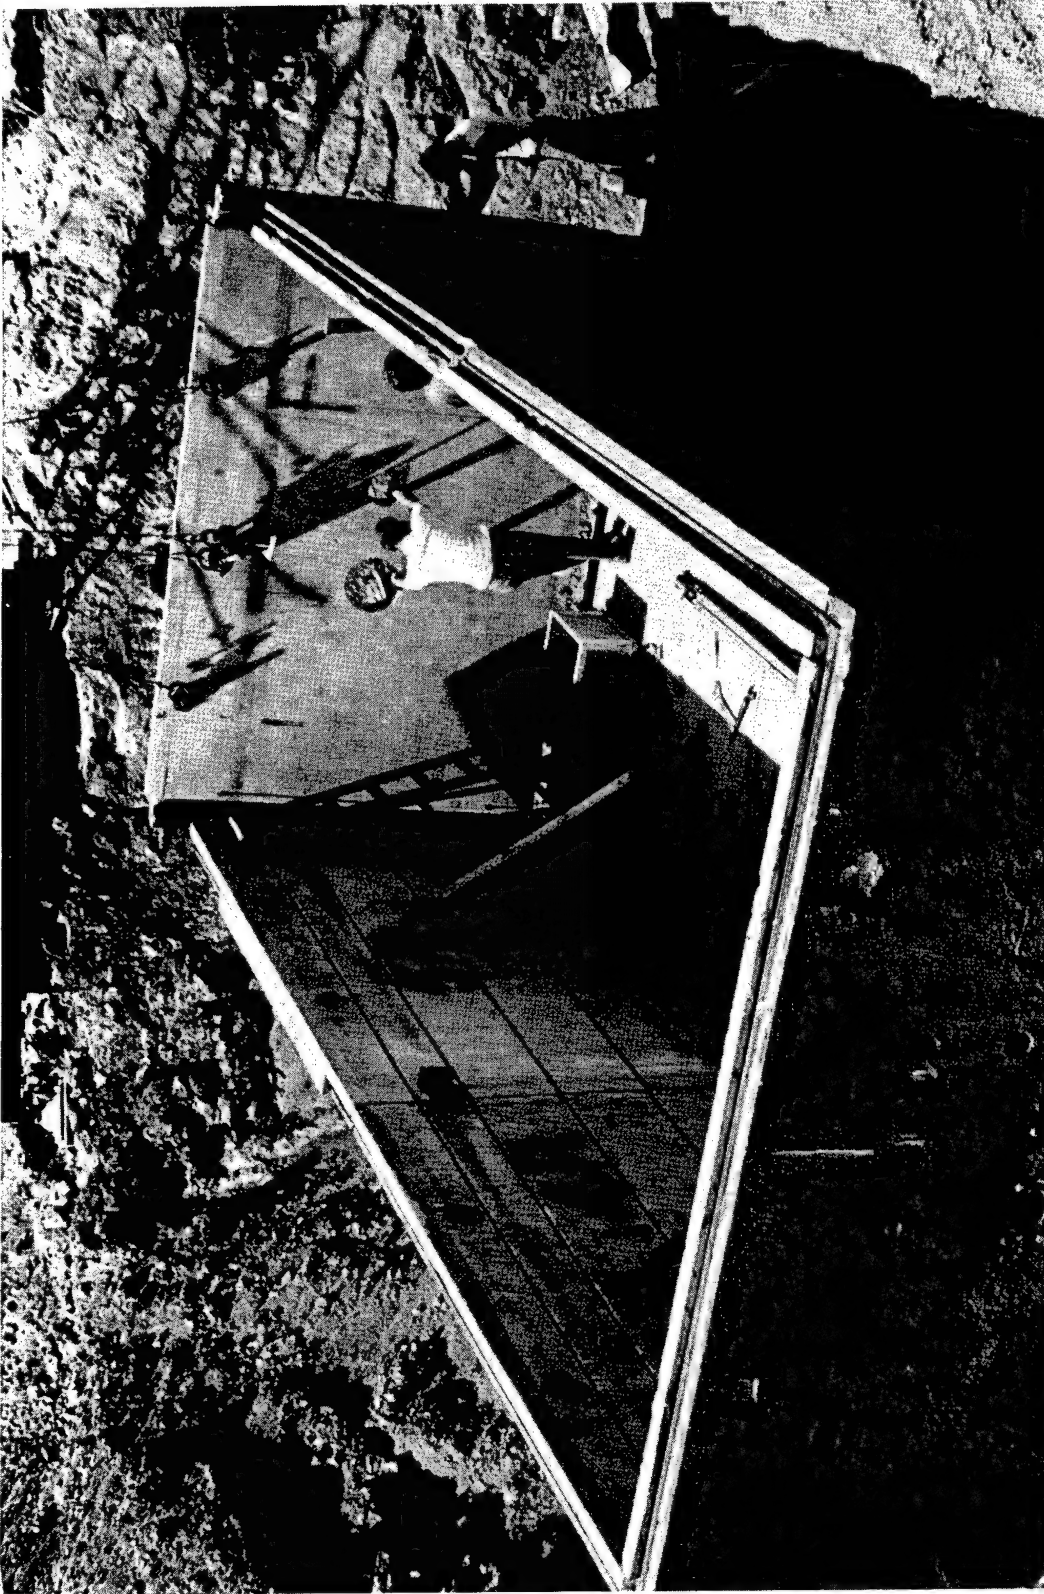
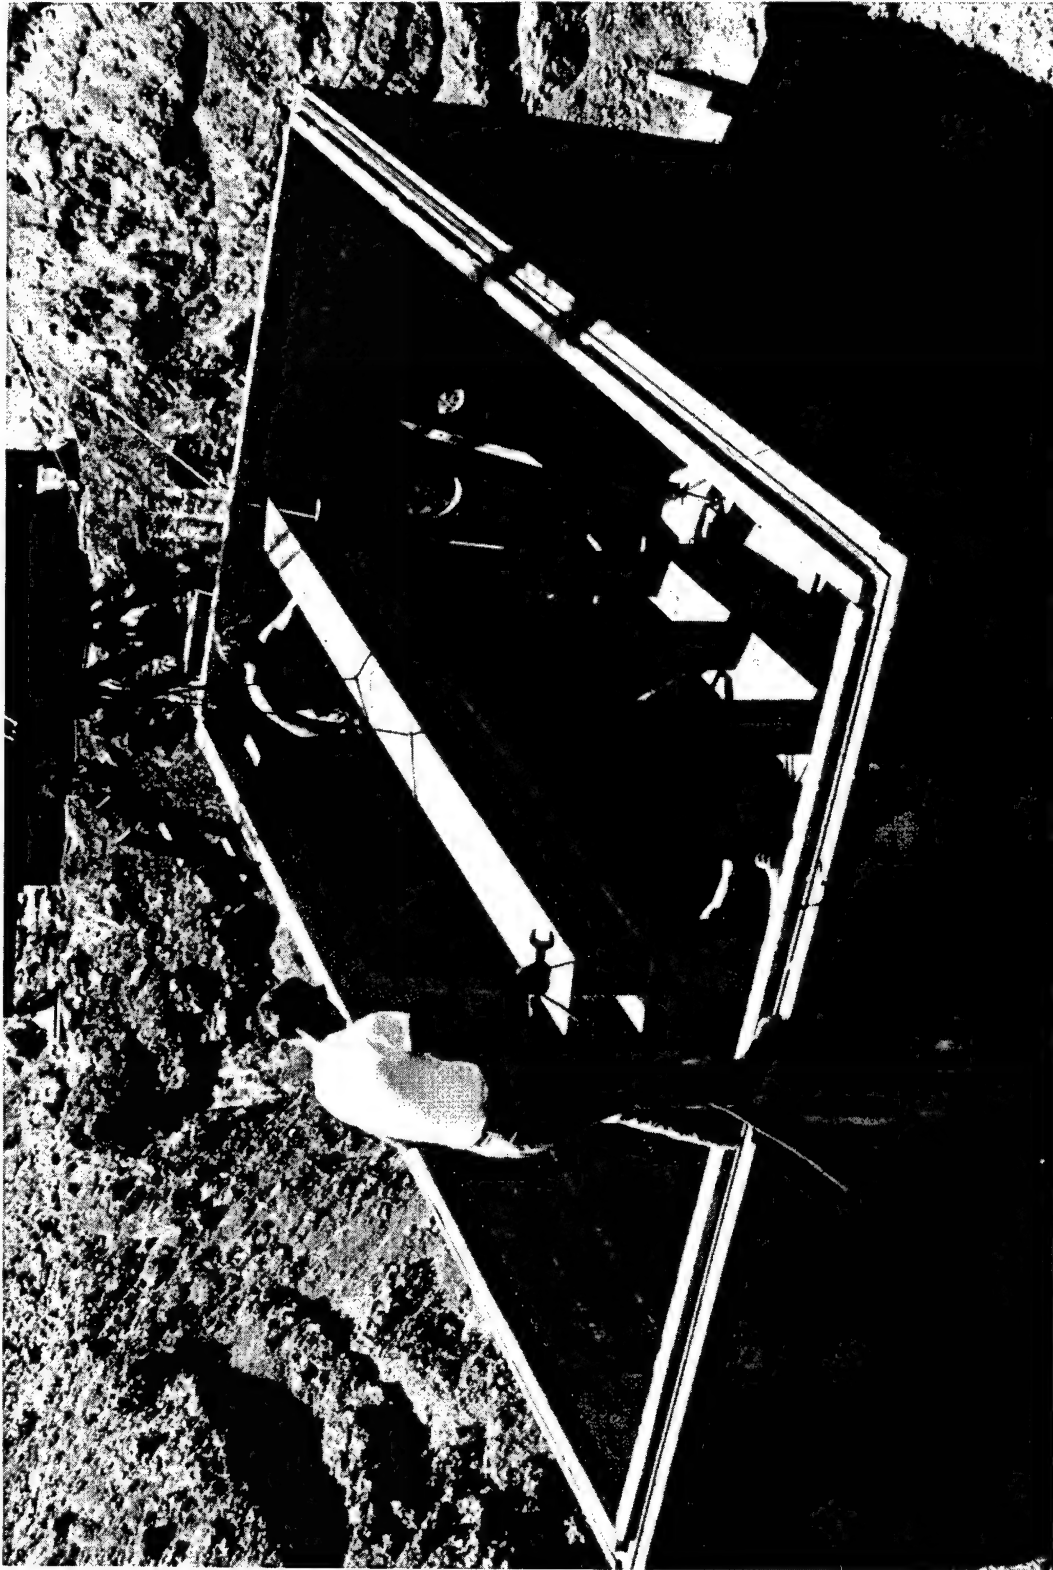
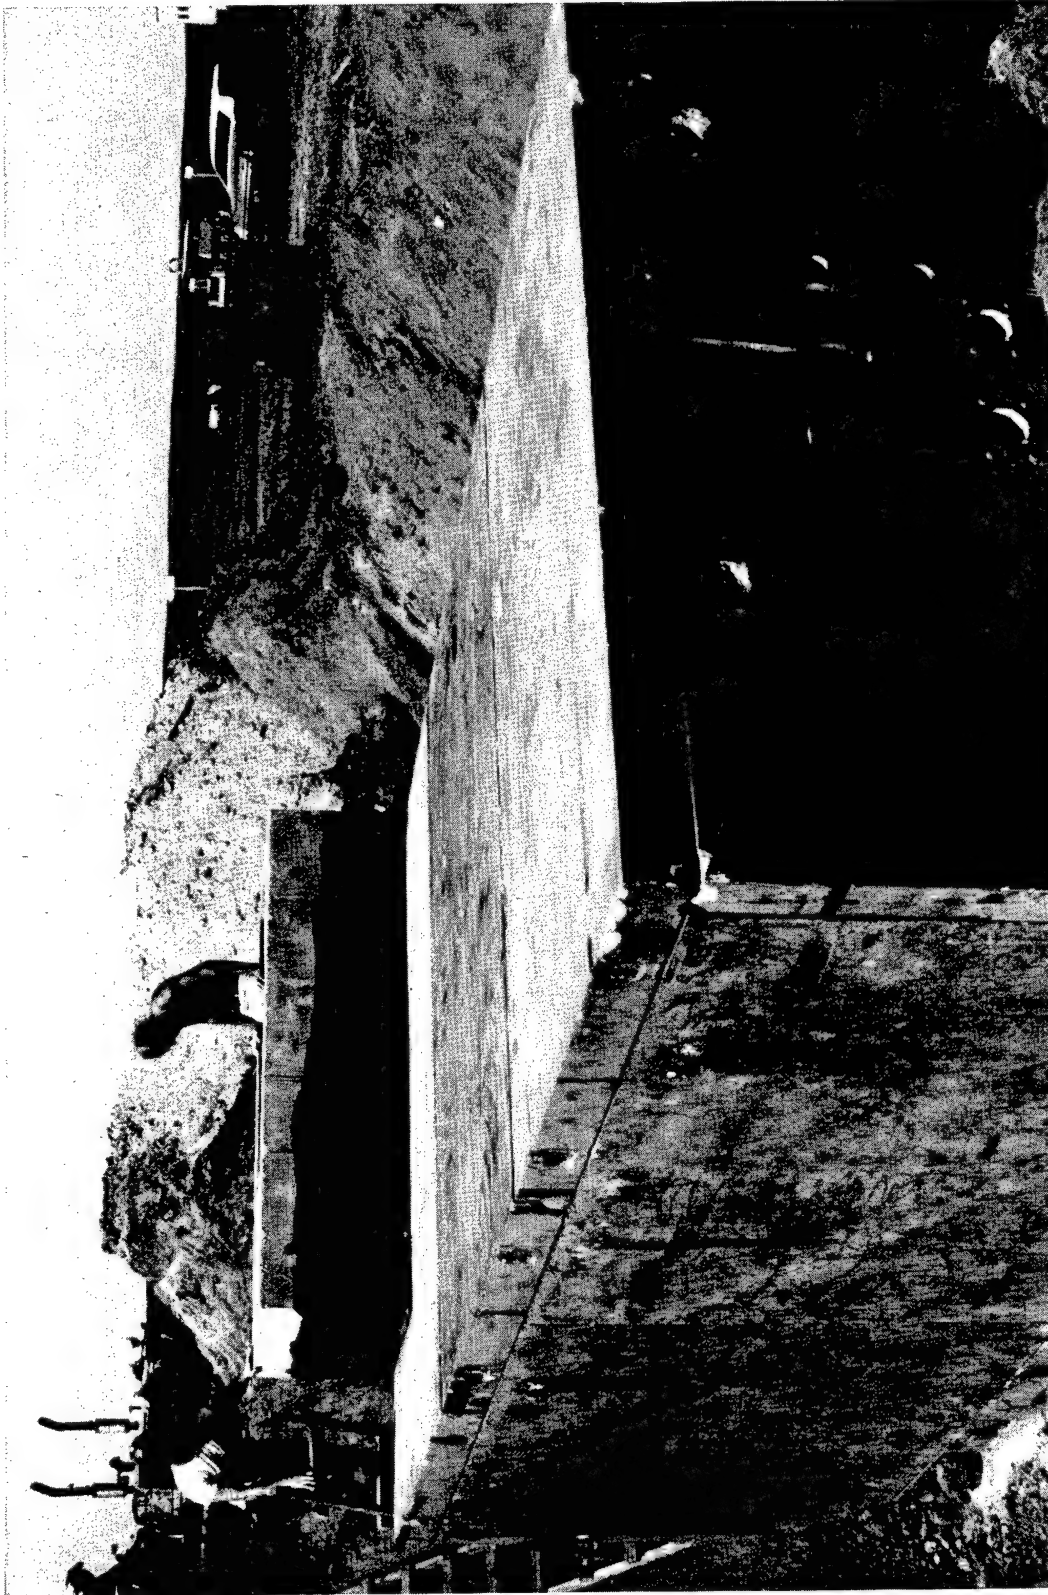
Figure 4. --Assembly of Manhole (page 1 of 10).

Figure 5. ---Assembly of Manhole (page 2 of 10).

Figure 6. ---Assembly of Manhole (page 3 of 10).

Figure 7. --Assembly of Manhole (page 4 of 10).

Figure 8. --Assembly of Manhole (page 5 of 10).

Figure 9. --Assembly of Manhole (page 6 of 10).

Figure 10. --Assembly of Manhole (page 7 of 10).

Figure 11. ---Assembly of Manhole (page 8 of 10).

Figure 12. --Assembly of Manhole (page 9 of 10).

Figure 13. --Assembly of Manhole (page 10 of 10).

Figures 4 through 13 show the assembly of the manhole. Shown in figure 14 is the blast hatch used on the SA Manhole. Normally, the hatch was latched in place by means of four bars, activated either by handles from within, or from the outside by means of a special wrench. In the DIAL PACK Event, each hatch-half was bolted with four bolts. One set consisted of instrumented strain bolts which permitted determination of rebound forces.

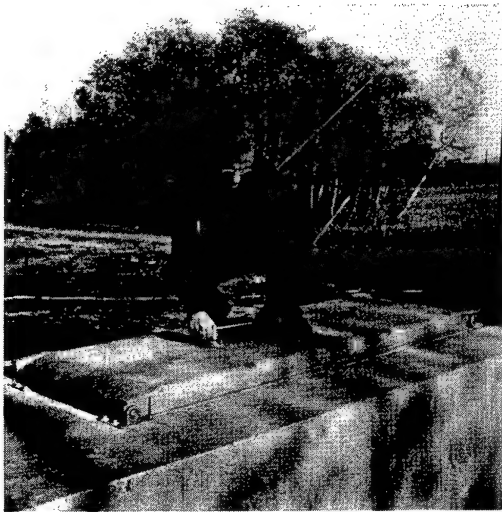
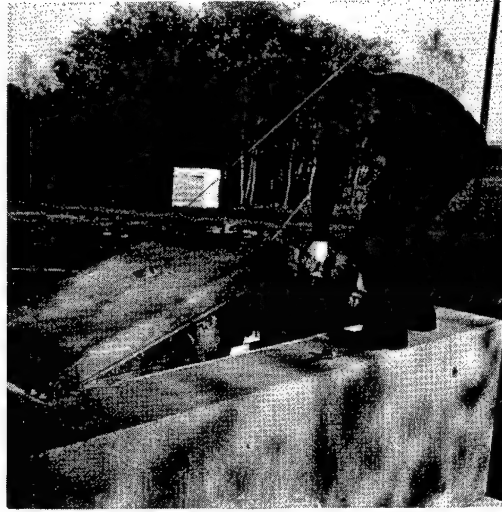
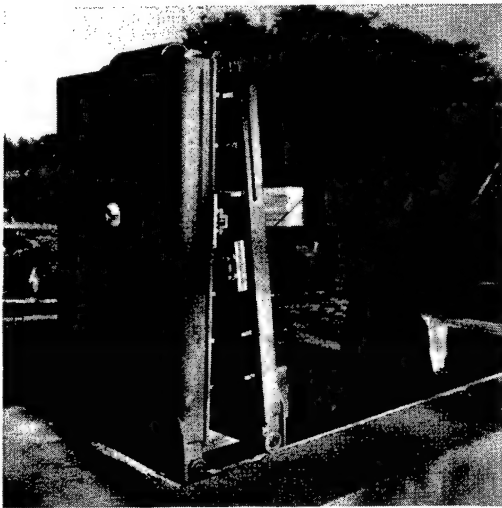
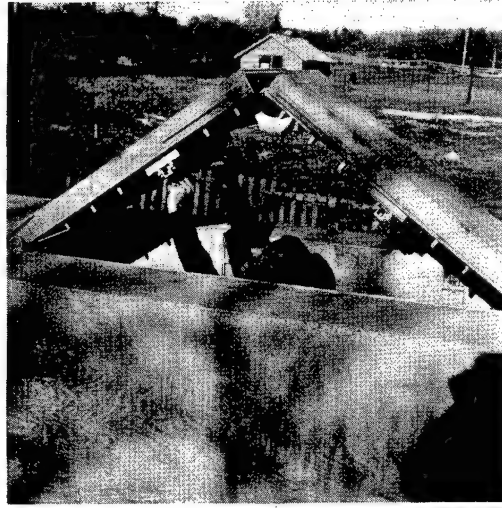
Figure 14. --Blast hatch used on SA Manhole.

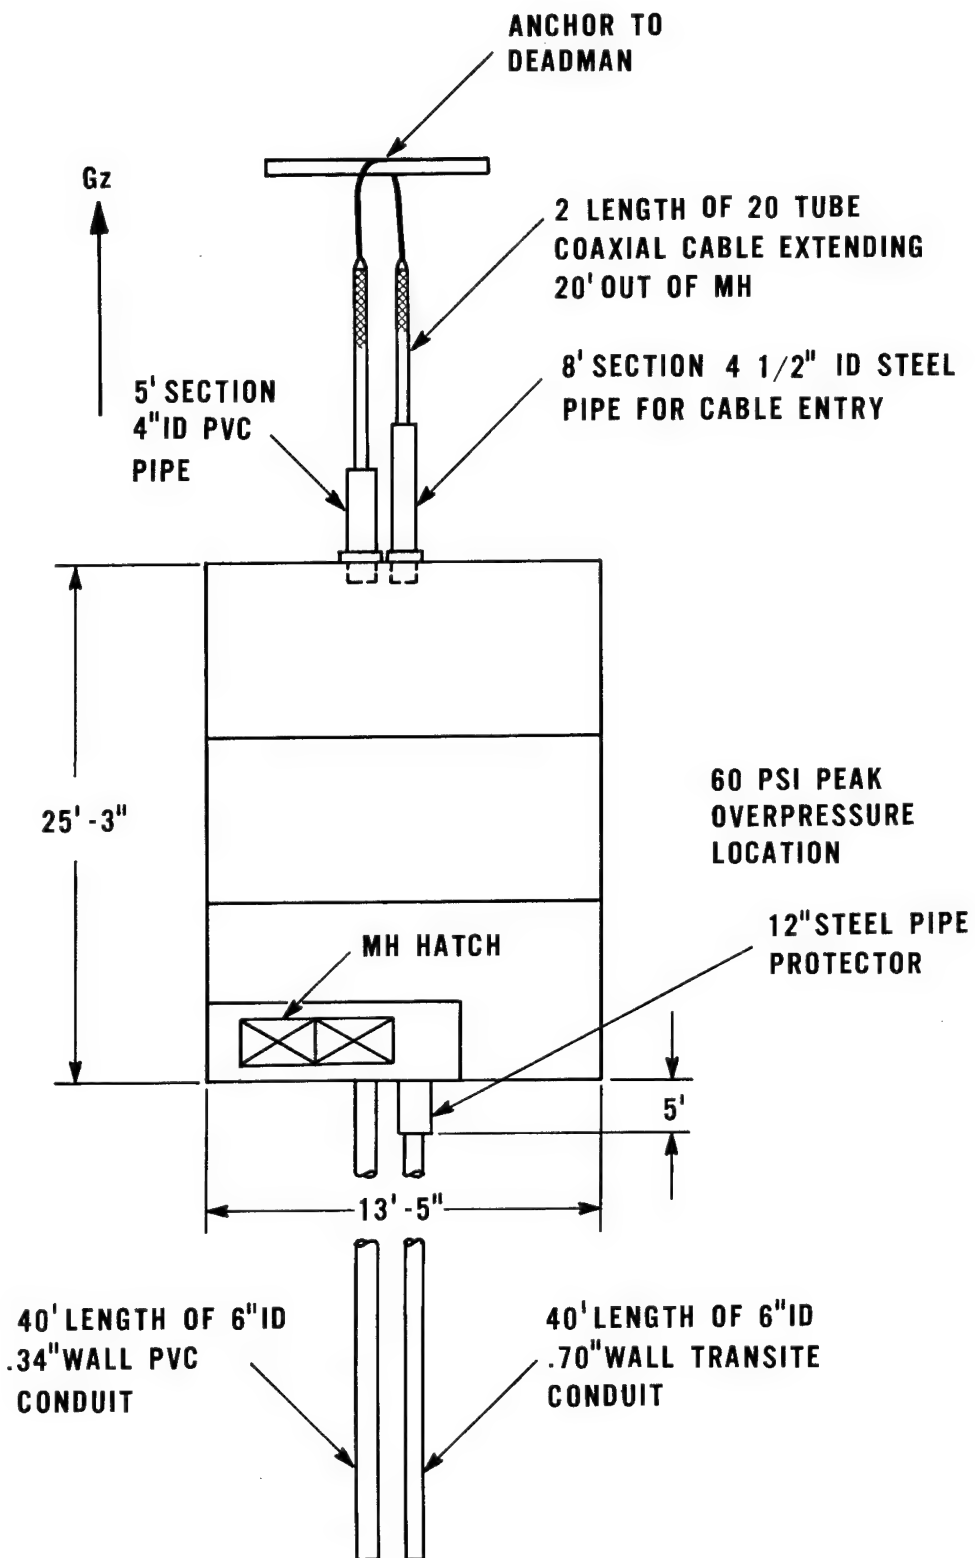
Figure 15. --Test installation.

The test installation is shown in plan in figure 15. As noted previously, the center of the manhole was located at the 60-psi range, with the long axis of the manhole oriented radially from GZ.

On the end of the manhole toward GZ, two 20-tube coaxial cables were installed to simulate a long cable run entering the manhole. Two types of cable entry pipes were installed: a 5-foot length of 4-inch ID PVC pipe (proposed for use), and an 8-foot length of 4-1/2-inch ID steel pipe. Each cable entry pipe penetrated the manhole wall and was grouted in place and bolted to the outer surface by means of a flanged connection. The cables were anchored externally to a deadman and were tied inside the manhole to the center structural steel frame to simulate the normal cable termination at a splice. The cables were installed at a depth of 4 feet below the original grade.

Two 40-foot lengths of conduit, one constructed of cement-asbestos, and the other of poly-vinyl-chloride (PVC), were located on the end of the manhole away from GZ. Both conduits had nominal inside diameters of 6 inches. The wall thickness of the relatively rigid cement-asbestos conduit was 0.70 inch, while that of the PVC conduit was 0.34 inch.

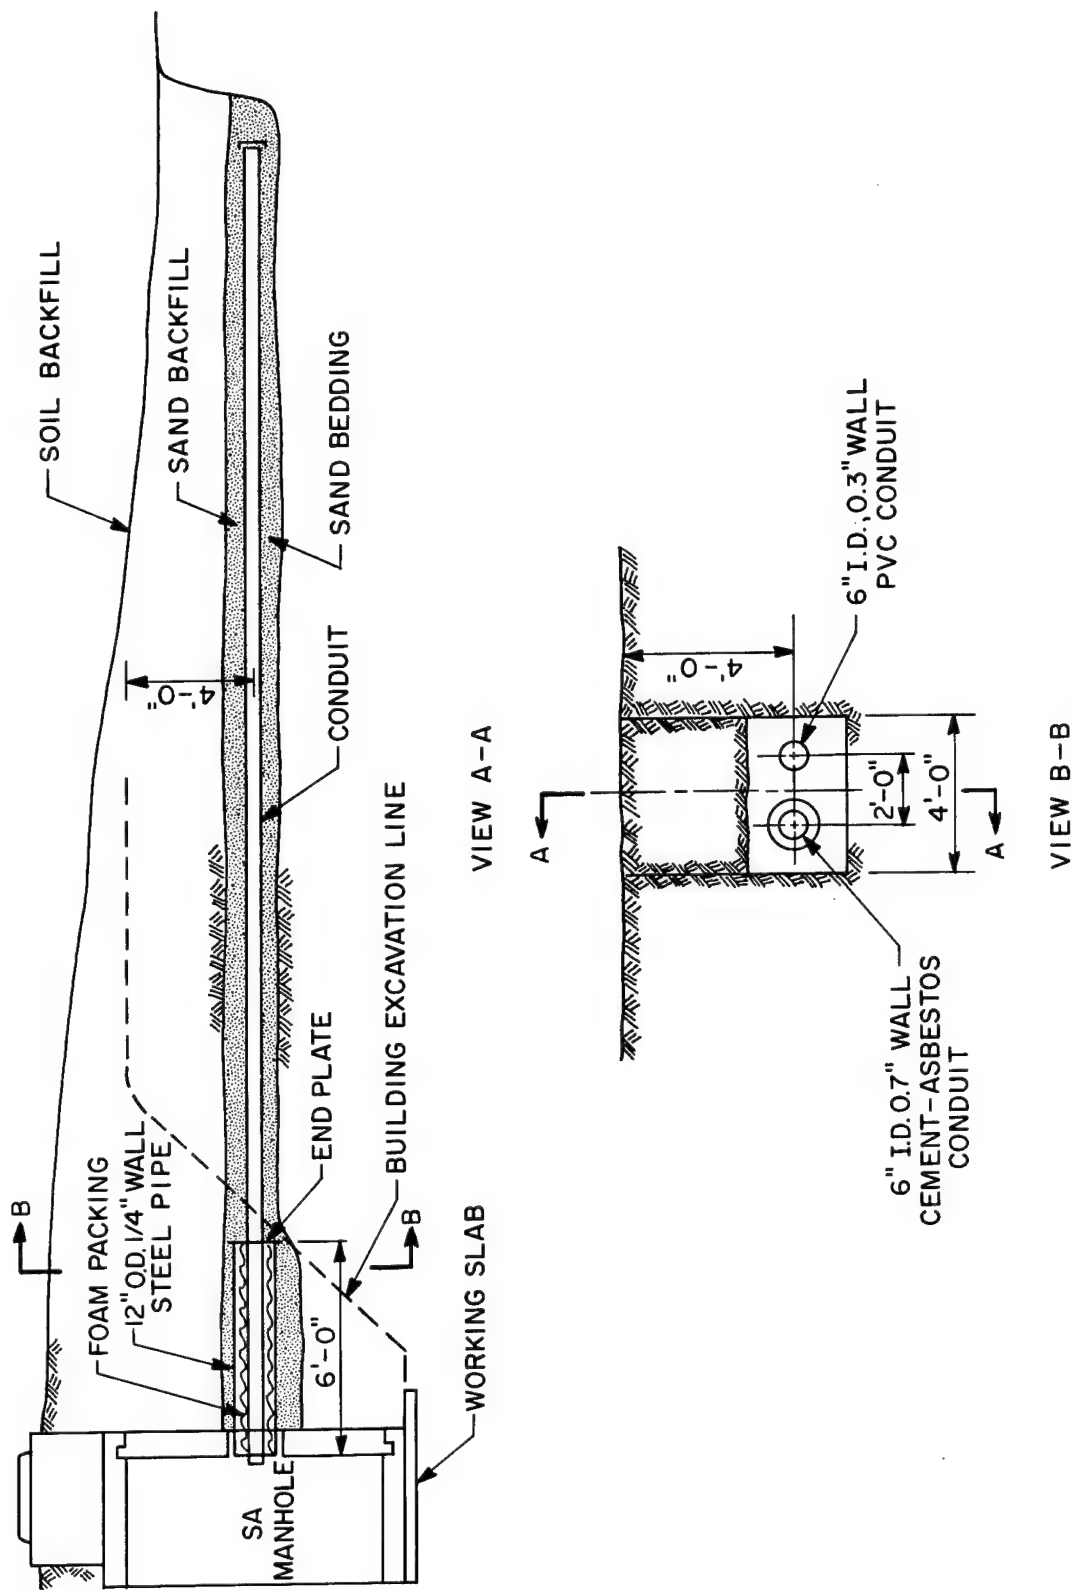
Figure 16. ---Elevation view of the conduit installation.

Figure 16 shows an elevation view of the conduit installation. The excavation region surrounding the building was somewhat larger than originally anticipated. In the area where the conduits and cable crossed the excavation region, the back-fill under the conduits and cables was compacted. The natural soil was pushed into the void against the manhole end-walls to a height just below the entry holes for the conduit and cable (about a 3-foot depth), after which about 1,000 gallons of water were used to partially compact the soil by "puddling." Then, a few inches of additional soil were added on top of the wet soil to permit additional compaction by means of an impact-type motor driver-compactor. The result of this process was less than an optimum soil compaction but modeled a situation likely to occur in actual practice.
